FINAL REPORT  
ON THE COLLISION BETWEEN A  
CARGOLUX OPERATED BOEING 747-400F  
REGISTERED LX-OCV  
AND A MAINTENANCE VAN  
ON RUNWAY 24  
AT LUXEMBOURG AIRPORT (ELLX)  
ON 21 JANUARY 2010, 11:53 UTC

DATE OF ISSUE : 10 DECEMBER 2012

**Report N° AET-2012/AC-01**

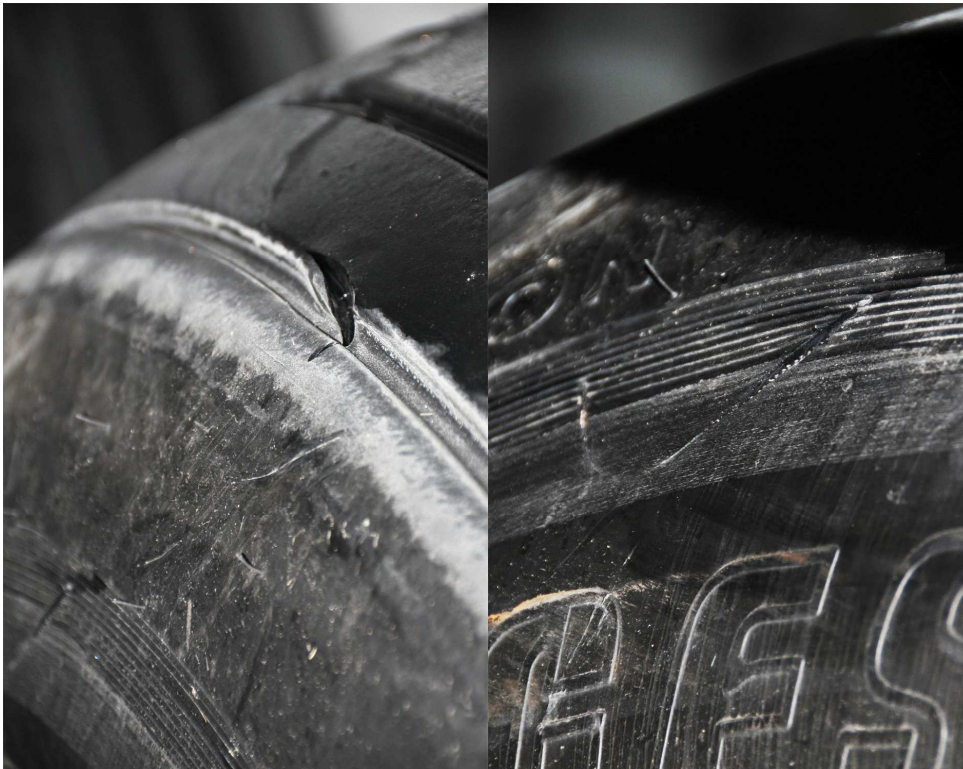
Damage to the aircraft was limited to cuts on tire nr 12 located on the right hand body landing gear, sustained from impact with the van's lightbar which was ripped off. The tire had to be replaced. It is unlikely that the damage to the tire could stem from a previous flight considering that the tires nr 11 and 12 had been replaced shortly before in Hong Kong and that the Barcelona-Luxembourg leg was the 3<sup>rd</sup> flight since the replacement.

Picture 1: Tire nr 12 (Source AET)

The impact of CLX 793 with ELE 23 took place during the flare at a height of approximately 8 feet above the touchdown zone of runway 24. The airplane impacted the roof of the van with wheel nr 12 on the right hand side body landing gear, below the roofline on the inclined front section of the van. Wheel nr 12 damaged the roof on the whole length of the vehicle, ripping off the lightbar and the R/T antennas. Wheel nr 12 sustained several cuts, including side cuts, and had to be replaced. No structural aircraft parts were damaged during the occurrence.

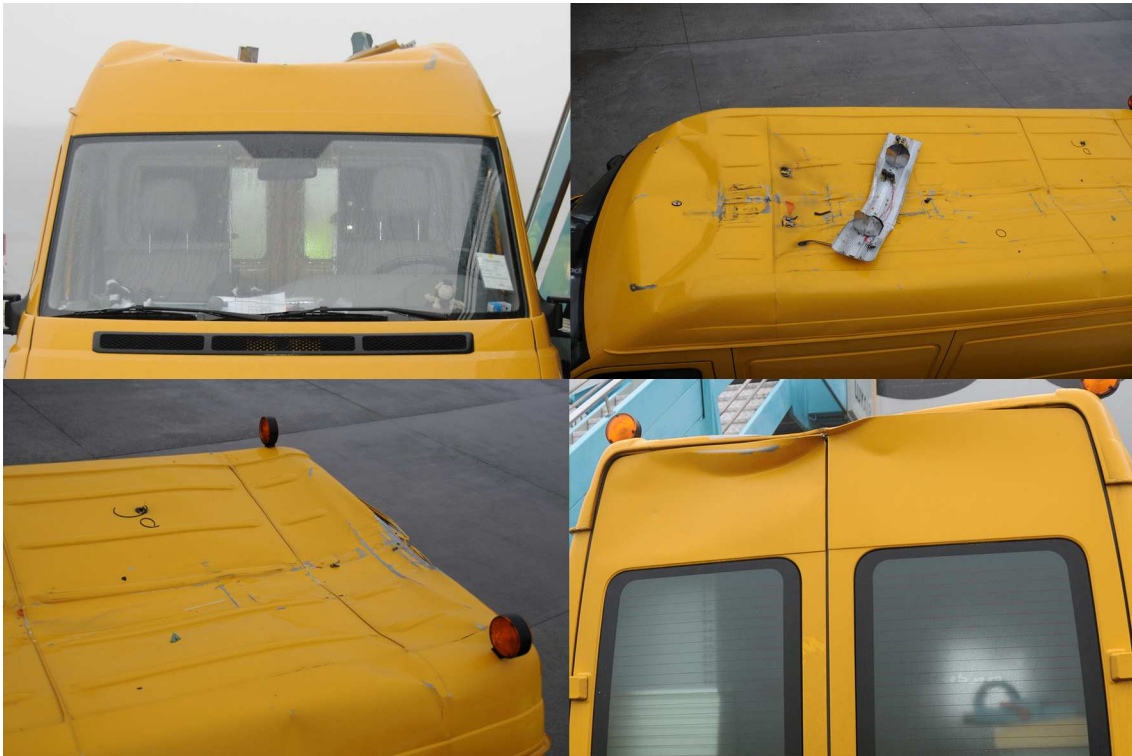
The roof of the maintenance van was damaged on the whole length of the vehicle. The light-bar and the R/T antennas were ripped off on impact.

Picture 2: Van 'ELE23' (Source AET)

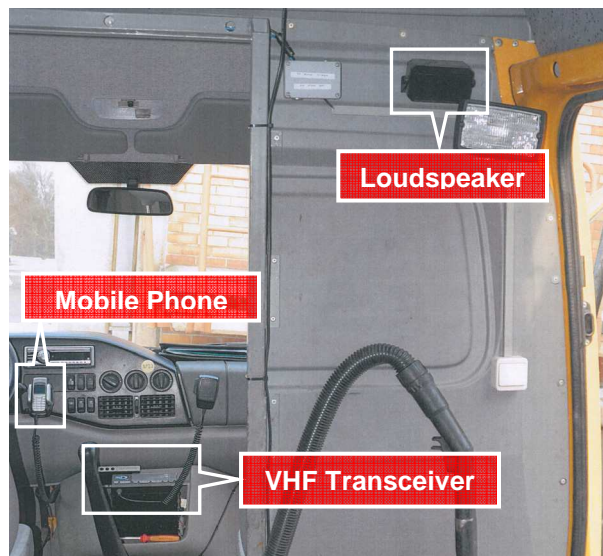
The radiotelephony (R/T) equipment available to the ELE 23 maintenance crew was a built-in VHF transceiver connected to an external loudspeaker located near the van's sliding door, enabling the ELE crew to maintain a listening watch on communications with TWR while working outside. Furthermore, the maintenance crew was equipped with a mobile phone and was provided with a list of important telephone numbers, including the one for the TWR unit, enabling them to contact TWR if needed (e.g. R/T equipment failure). The mobile phone number of ELE 23 maintenance crew was however not known to the TWR unit.

Picture 3: 'ELE23' R/T Equipment (Source ANA)

A handheld VHF transceiver was not part of the R/T equipment provided to ELE 23 as in some parts of the manoeuvring area, it was not possible with this type of equipment to maintain a communication link with TWR.

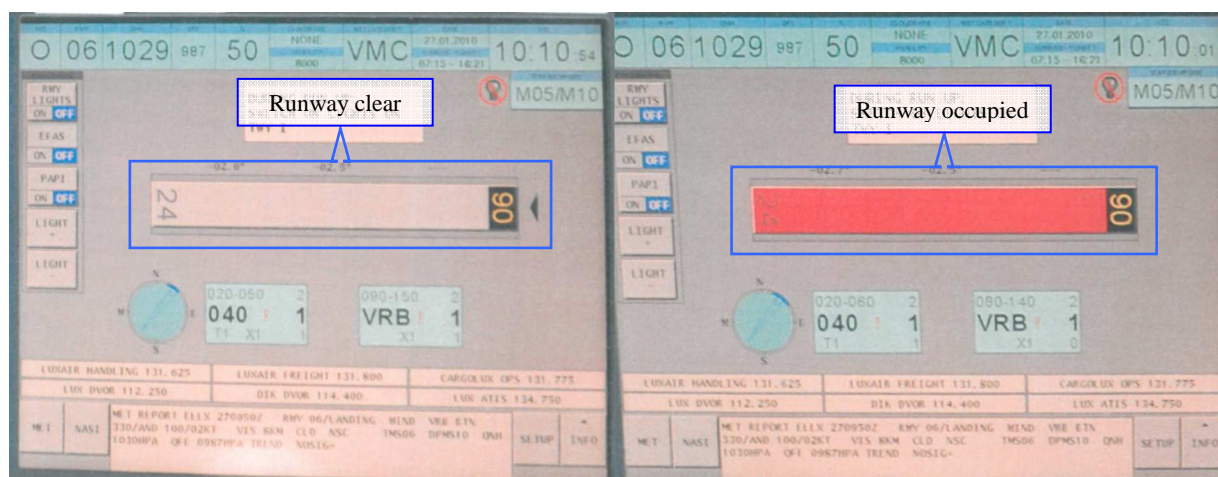
Picture 5: ADD (Source ANA)

The ADD was in an evaluation phase at the time of the occurrence and did not have operational status. The decision whether or not to use the system was left to the ATCO's on duty.

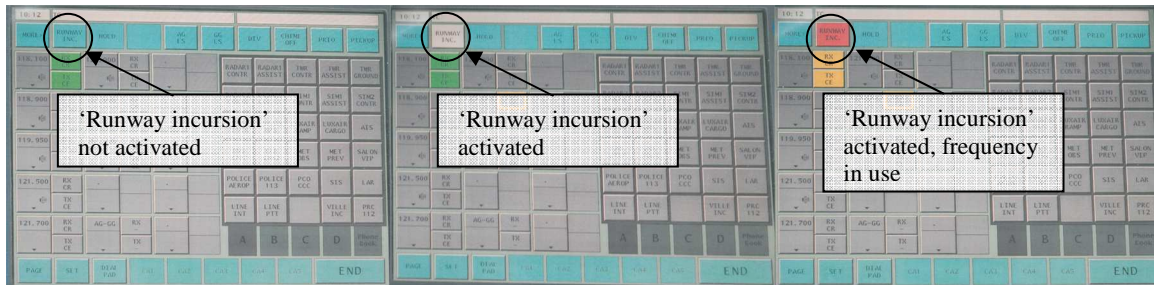
The command and frequency control touch screen of the R/T System on each CWP has a 'runway incursion' button on the upper left side. Upon manual activation of this button by the ATCO operating the CWP, its colour changes from blue to pink. When the selected frequency is used to transmit a communication, the colour of the 'runway incursion' button changes to red and an aural alarm activates on the specific CWP loudspeaker as a reminder that the function is active. It should be noted that the 'runway incursion' function only triggers an alarm for the active frequency on the specific position where it has been activated. This means that when the function is active on CWP2 for ground control frequency 121.9 MHz, a transmission from CWP1 on TWR frequency 118.1 MHz does not trigger the aural alarm.

Picture 6: R/T System (Source ANA)

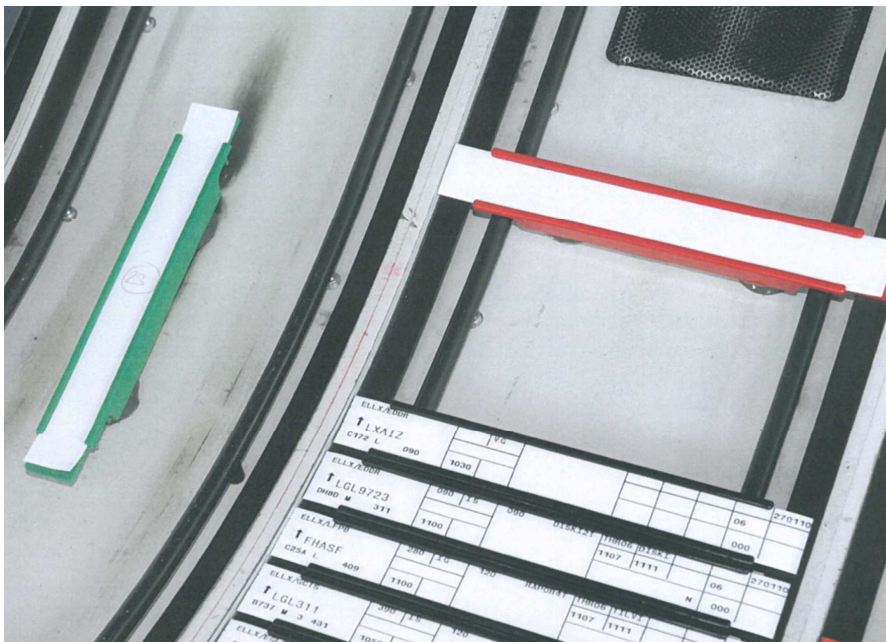
Picture 7: Strip Holder (Source ANA)

There were no published instructions in MATS regarding the marking of an occupied runway at the time of the occurrence. It was considered by ANA to be an elementary part of an ATCO's job to ensure that a RWY was unoccupied before issuing a landing clearance to an aircraft. Accordingly, the issue did not require to be addressed in MATS.

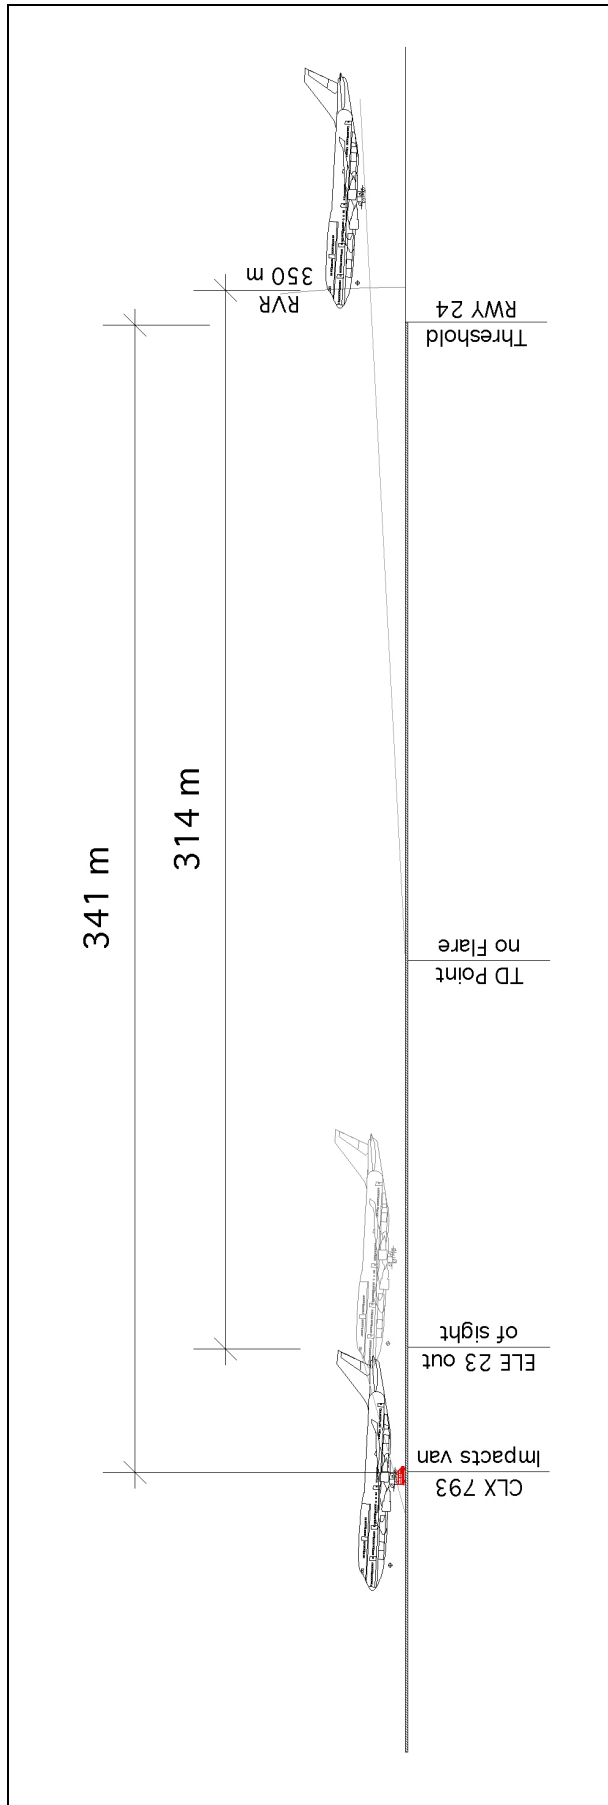
Figure 3: Landing Sequence: Source Boeing, VW, AET

The van was positioned at approximately 341 meters from the runway threshold and the aircraft had a groundspeed of approximately 150 kts (= 77 m/s) when crossing the threshold until shortly before touchdown. The horizontal distance travelled by the airplane over which the car could be seen was about 314 meters. Based on those numbers, the PF had an estimated 4 seconds to see the obstacle on the runway and to decide whether or not to take avoiding actions. The collision occurred half a second later. It should be noted that runway lights in the touchdown zone were at high intensity due to the prevailing fog, which made it more difficult for the pilot to identify any obstacle on the runway. Furthermore, when the pilot went head up during final approach, he was looking out for expected visual cues, not the unexpected presence of a runway obstruction.

In a conversation with the PM during taxi to the parking position, the PF mentioned that a go-around briefly flashed through his mind when he saw the car on the runway. The PF stated in the occurrence report that he saw the van in the touchdown zone for the first time after calling out 'landing' at 17 ft radar altitude. Initiating a go-around at that point would have resulted in an approximate altitude loss of 17 ft (= DH), accounting for the spool-up time of the engines and the subsequent recovery of a positive ROC. The roof of the van being situated 8 ft above the runway (nil runway slope on that portion), a collision with the van could not have been avoided. The landing sequence is illustrated in Figure 3.

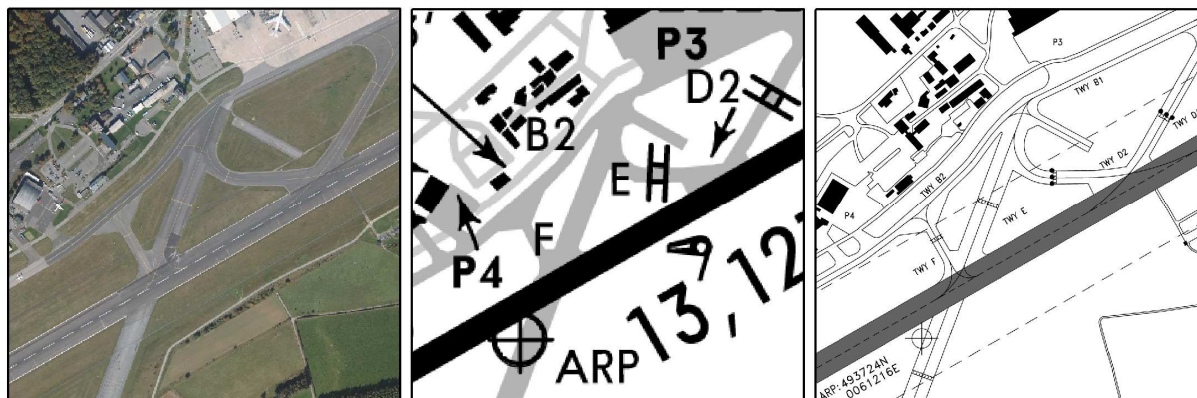
Figure 4: Aerodrome Chart (Source ACT, Jeppesen, AIP Belgocontrol)

The AIP states that with LVP in progress, *'arriving aircraft shall vacate the runway using exits C, D2, E or B4'*. The PM asking to vacate via taxiway Foxtrot instead of Echo is probably due to an inattention. The intention was to actually turn off the runway via Echo but the designators of taxiways Echo and Foxtrot were mixed up. This may partly be attributed to the fact that Echo and Foxtrot both have the same origin on the runway and that their depiction on the Jeppesen aerodrome chart could lead to confusion.
